A STERRAD 100 next to a 3M 5XL Steri-Vac.

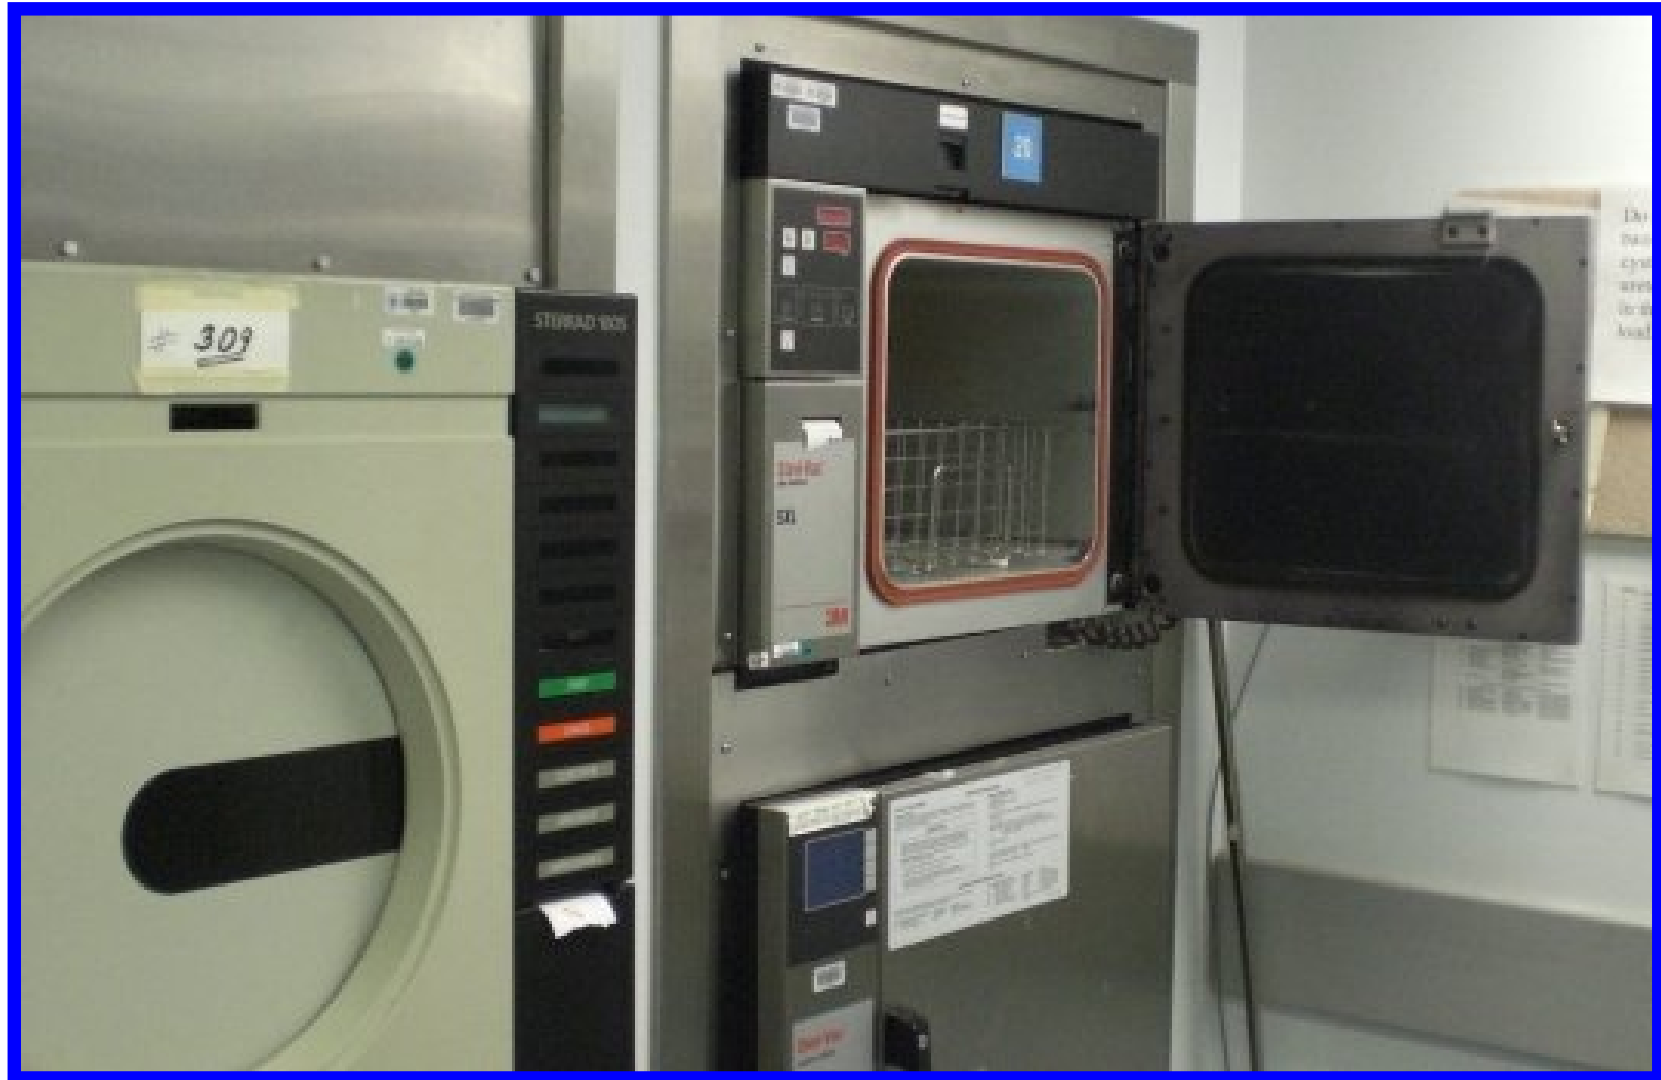
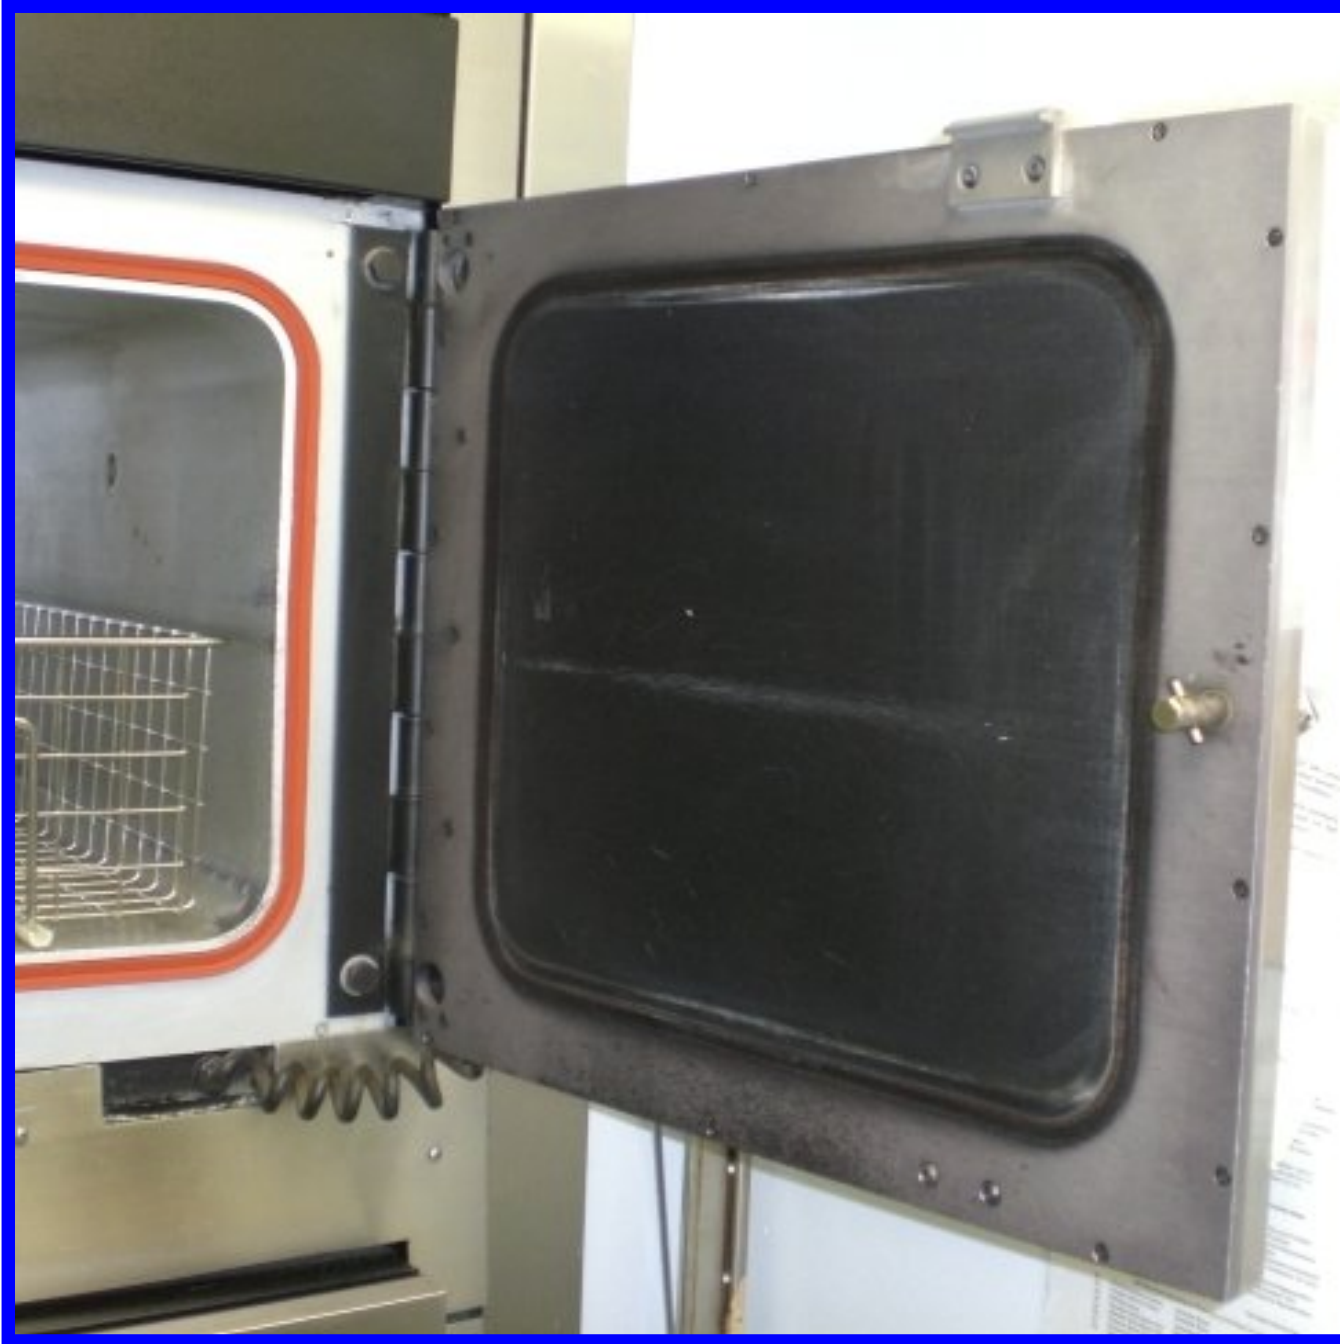
The black anodization is stripped off the door from the Hydrogen Peroxide exhausted from the STERRAD System.

The Steri-Vac door is anodized entirely black. The only black portion remaining after six months next to the STERRAD system is the area protected from the door gasket when the door is closed.

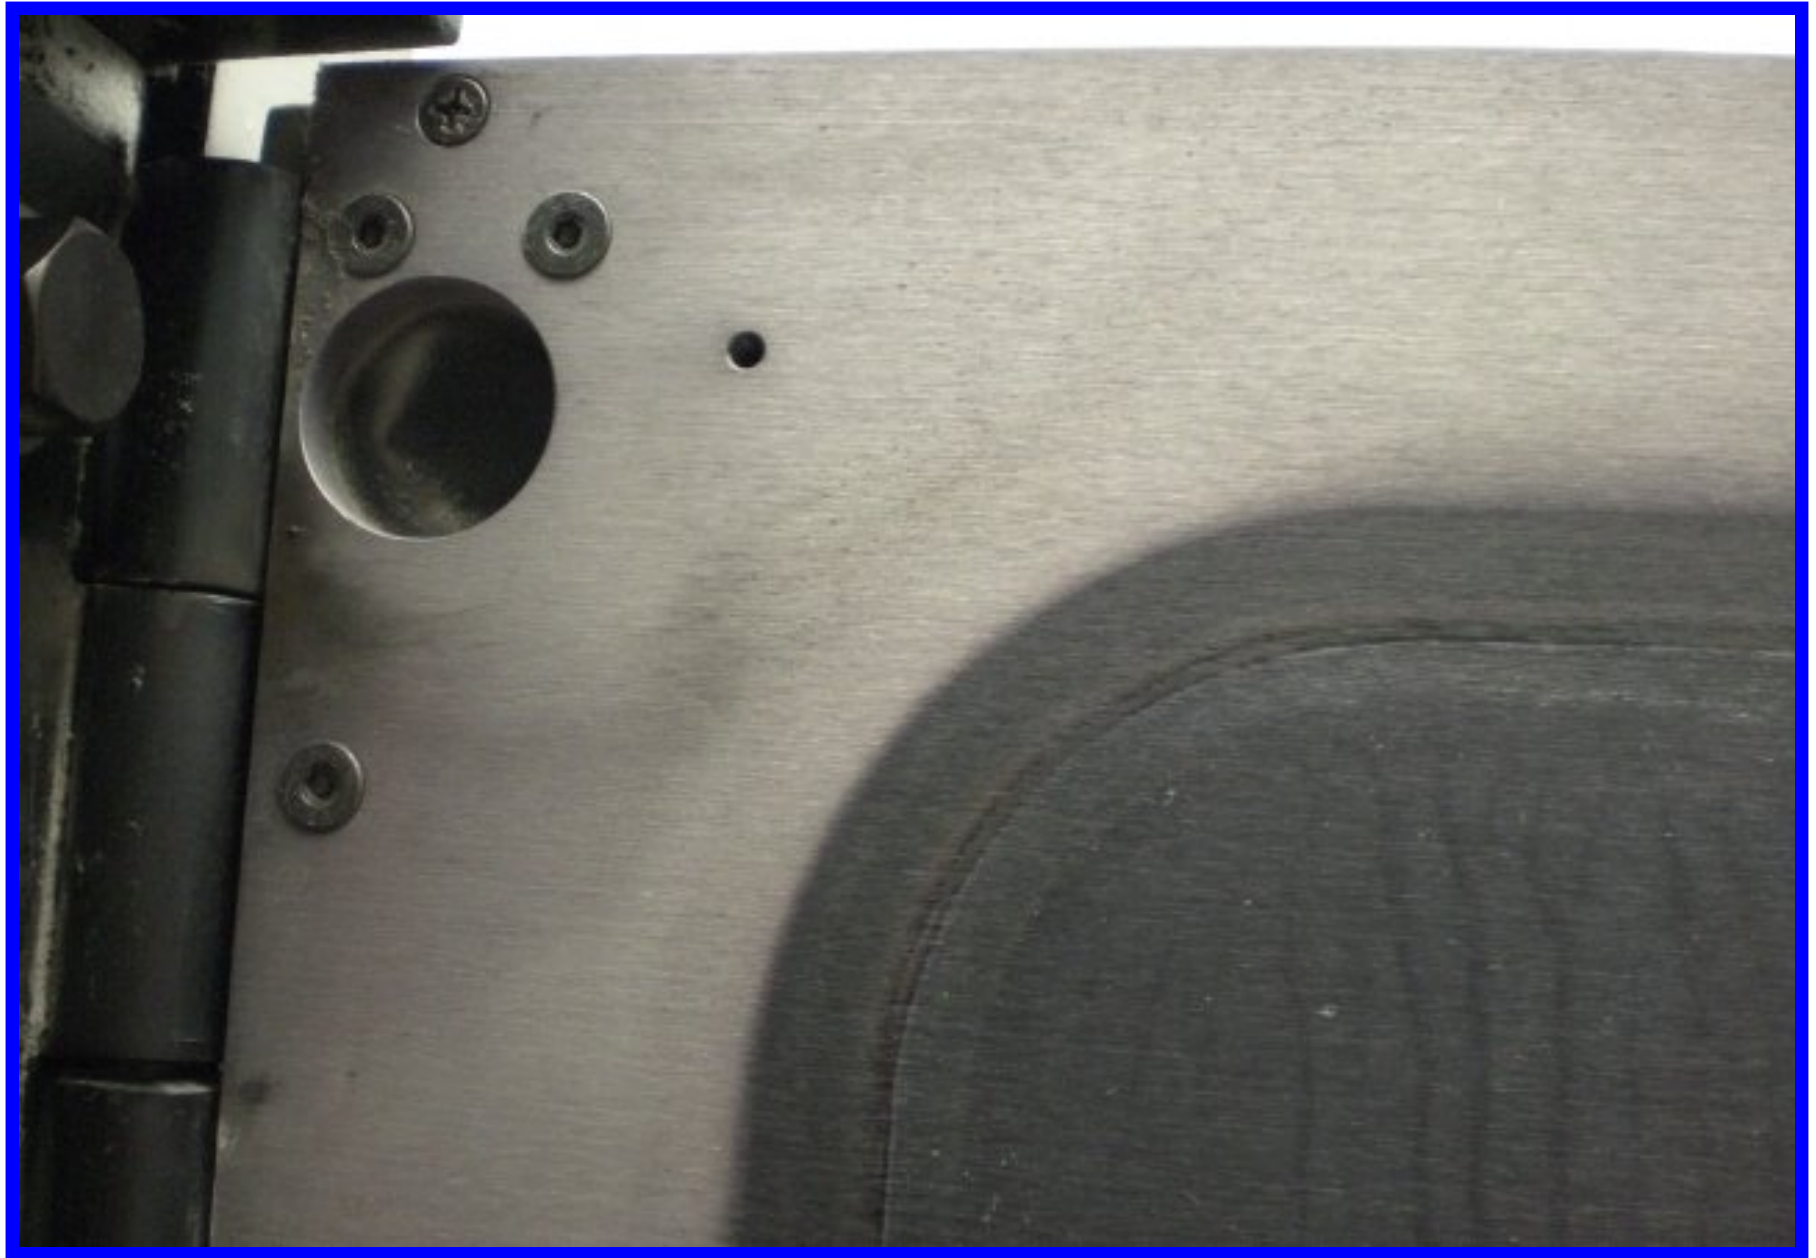
The removal of the anodization on the surface does not appear to affect the performance of the Steri-Vac.

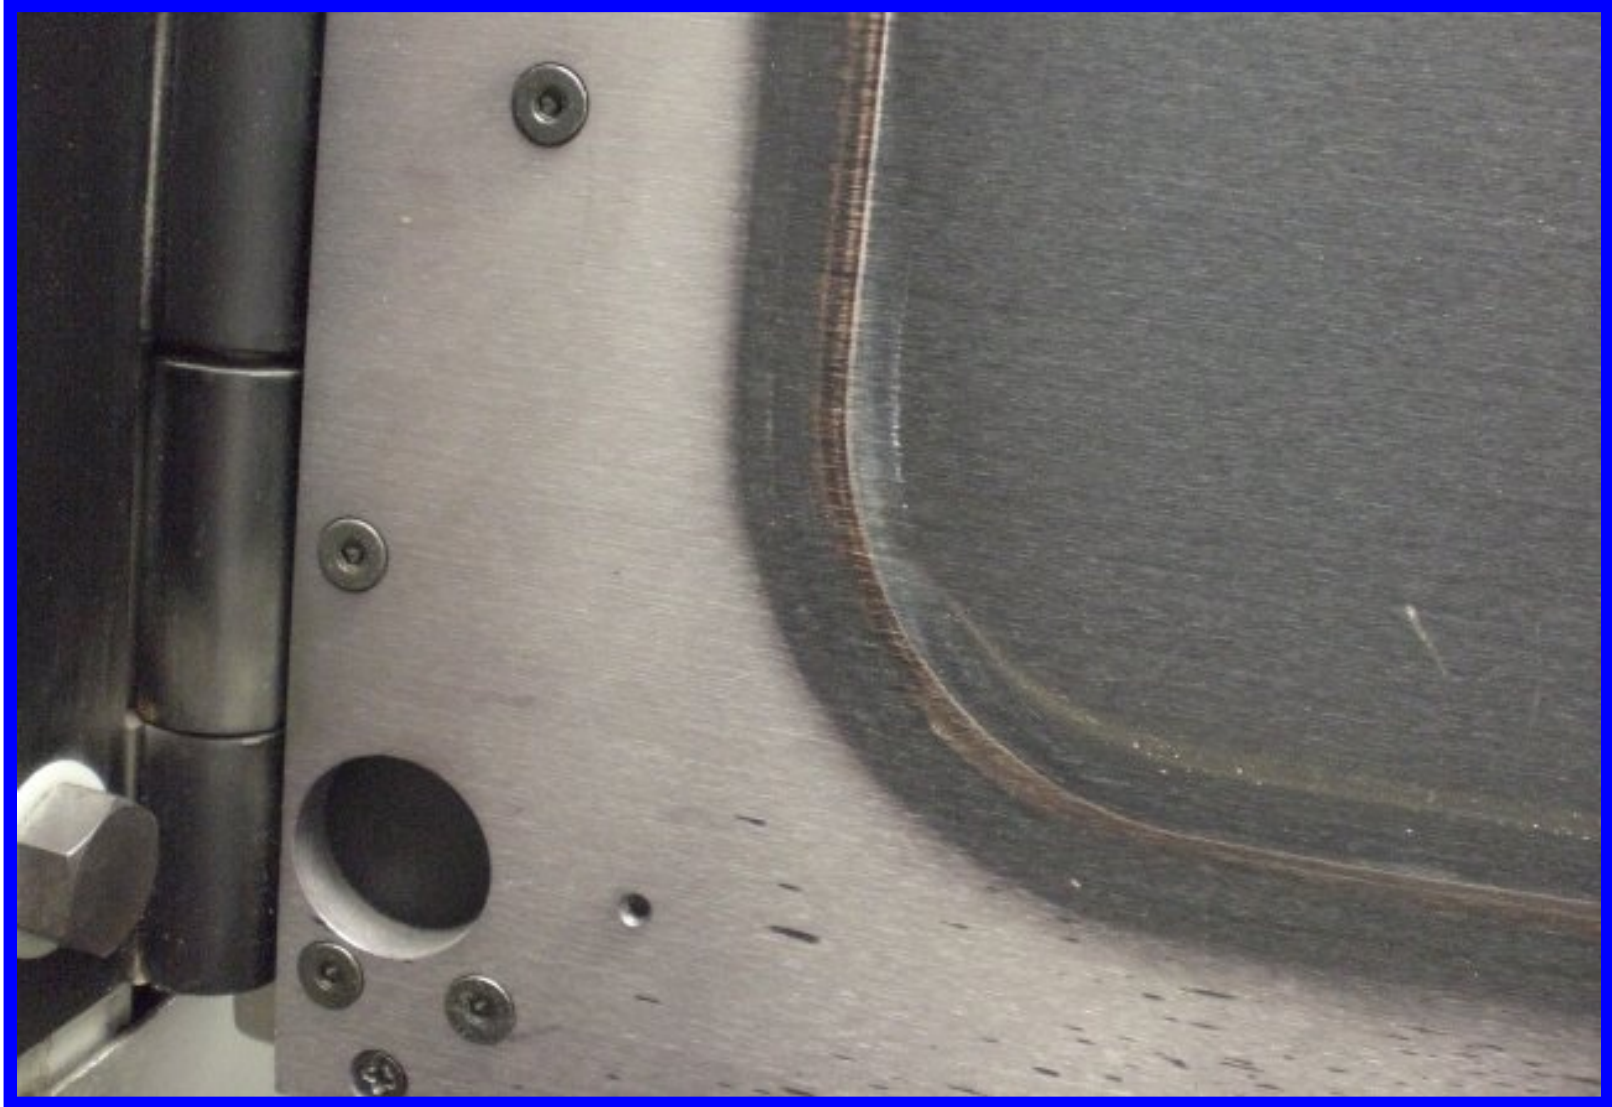
It does however indicate that Hydrogen Peroxide exhausted from the STERRAD sterilizer is present in the working environment and has not fully broken down.
