Annual WFHSS and JSMI Conference 2012
13th World Sterilization Congress

Problems on Hydrogen Peroxide Sterilisation — New Proposal for Safety and Effective Use —

Rika Yoshida, Hiroyoshi Kobayashi

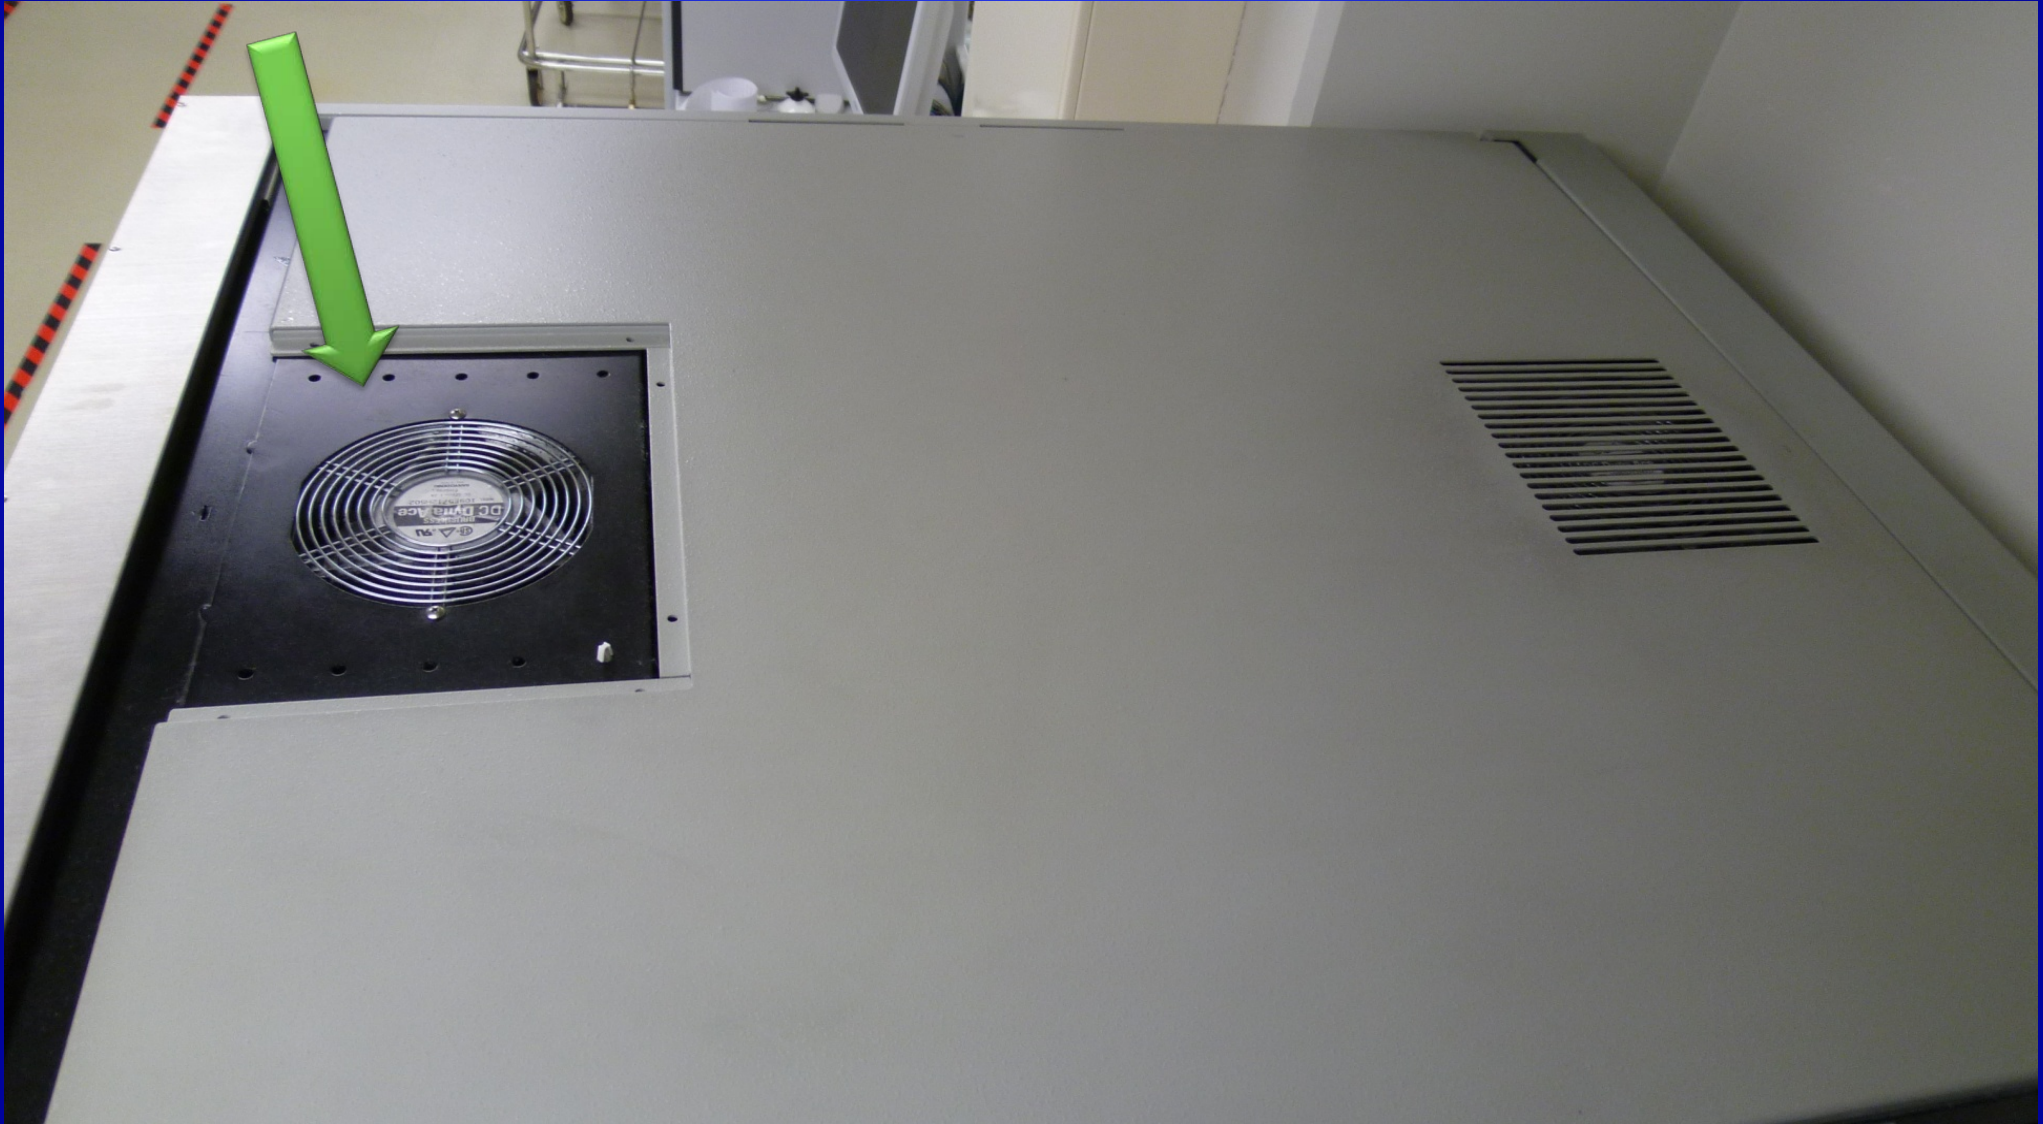
Concentration of Hydrogen Peroxide Vapour in the Proximity of STERRAD[®] 200

Upper Vent of the Steriliser

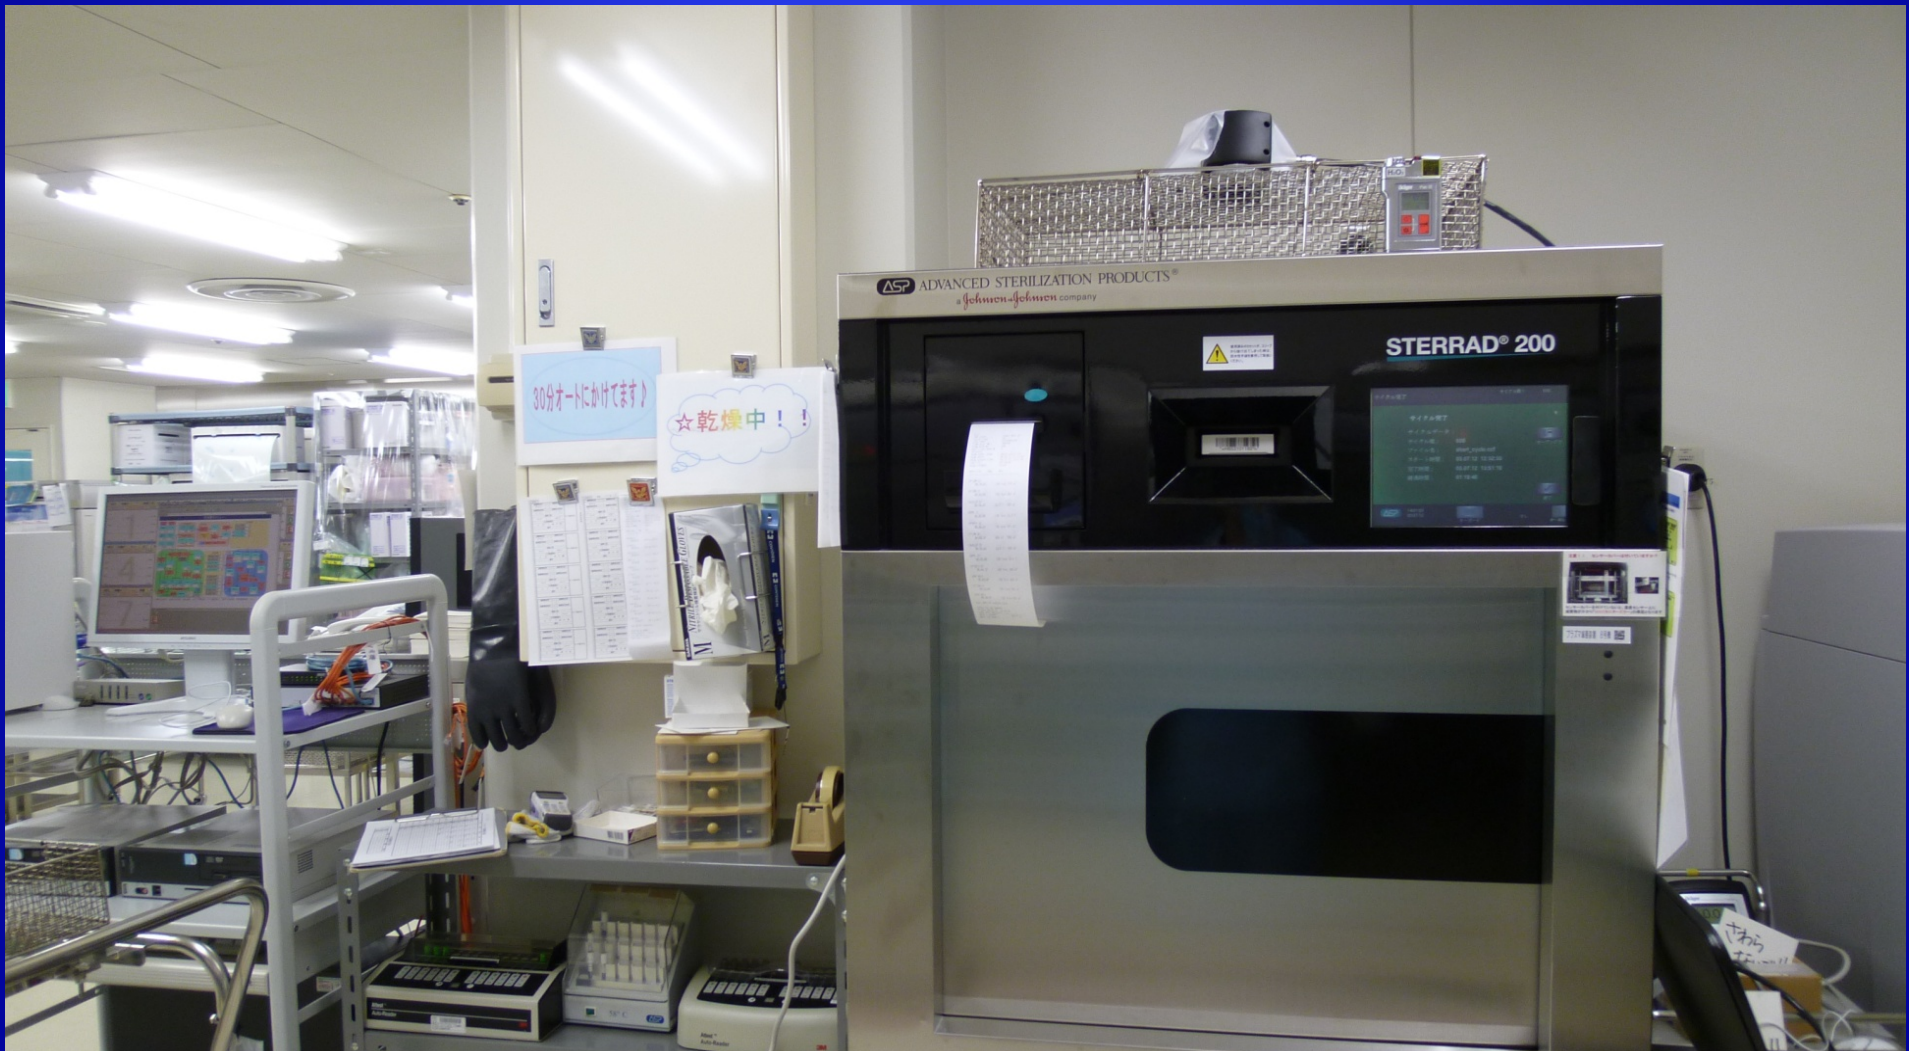
New STERRAD® 200

Beginning to use on 7 Oct, 2011

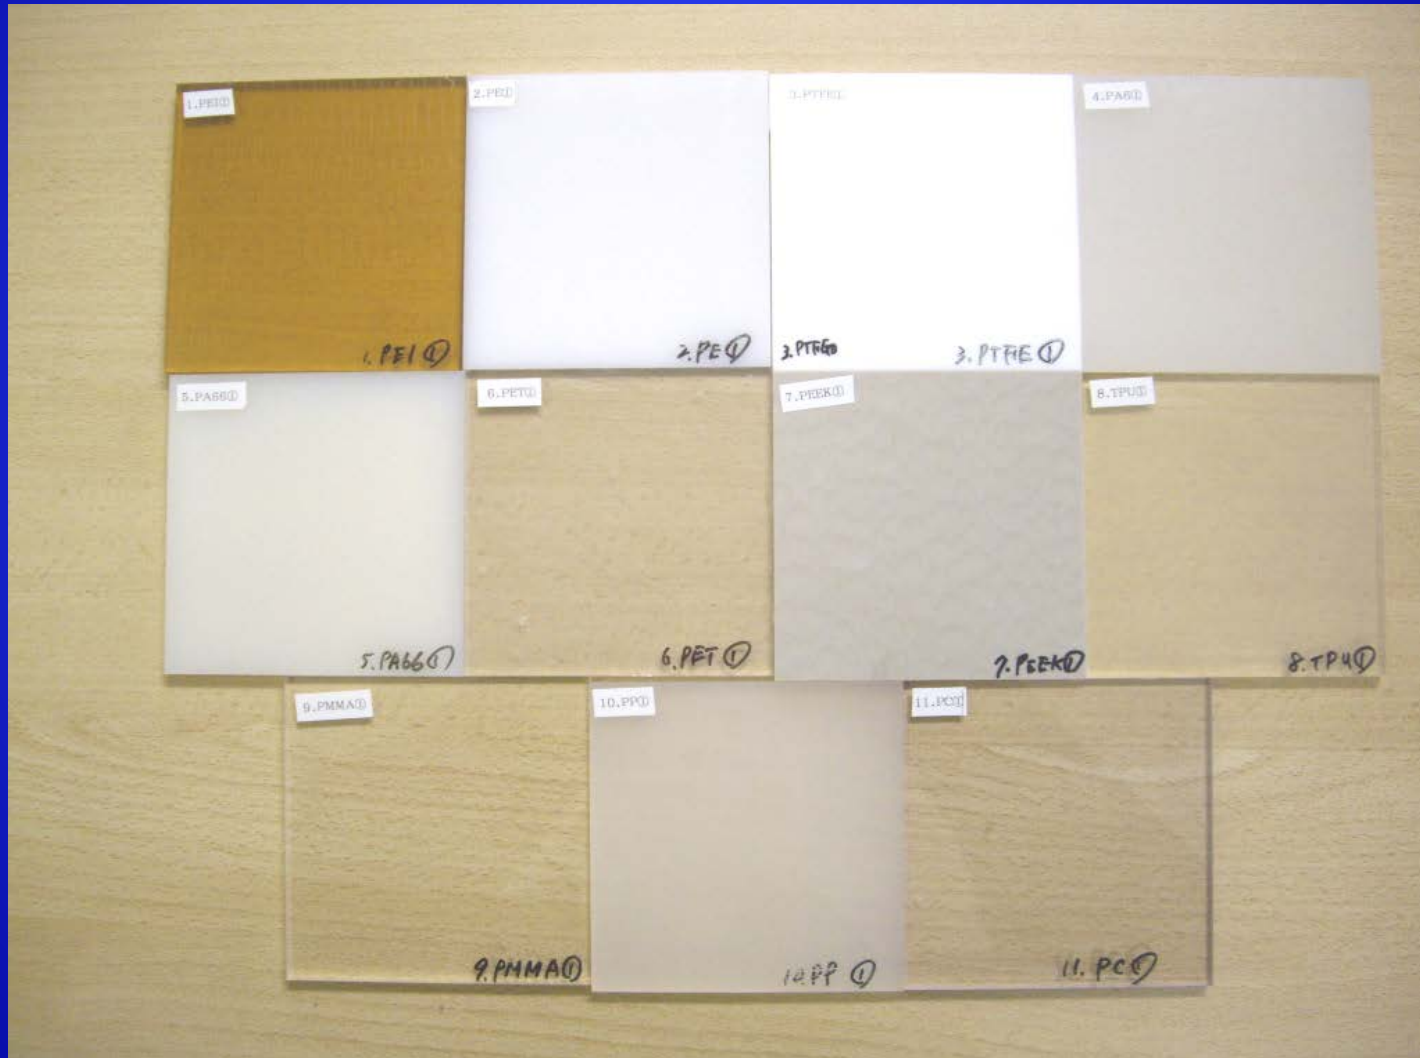
Eleven kinds of Plastic Test Panels

Eleven Kinds of Plastic Test Panels 100mm × 100mm × 6mm

- polyetherimide (PEI)
- polyethylene (PE)
- polytetrafluoroethylene (PTFE)
- polyamide 6 (PA6)
- polyamide 66 (PA66)
- polyethylene terephthalate (PET)
- polyetheretherketone (PEEK)
- thermoplastic polyurethane (TPU)
- polymethyl methacrylate (PMMA)
- polypropylene (PP)
- polycarbonate (PC)

- In the results of experimental detections of residual HPV on test plastic panels, those on PEI, polyamide 6 and 66, thermoplastic polyurethane (TPU), and polyethylene terephthalate (PET), polycarbonate (PC) showed more than 100ppm just after sterilisations.
- Forty- four days are needed to become less than 0.1ppm on the surfaces.

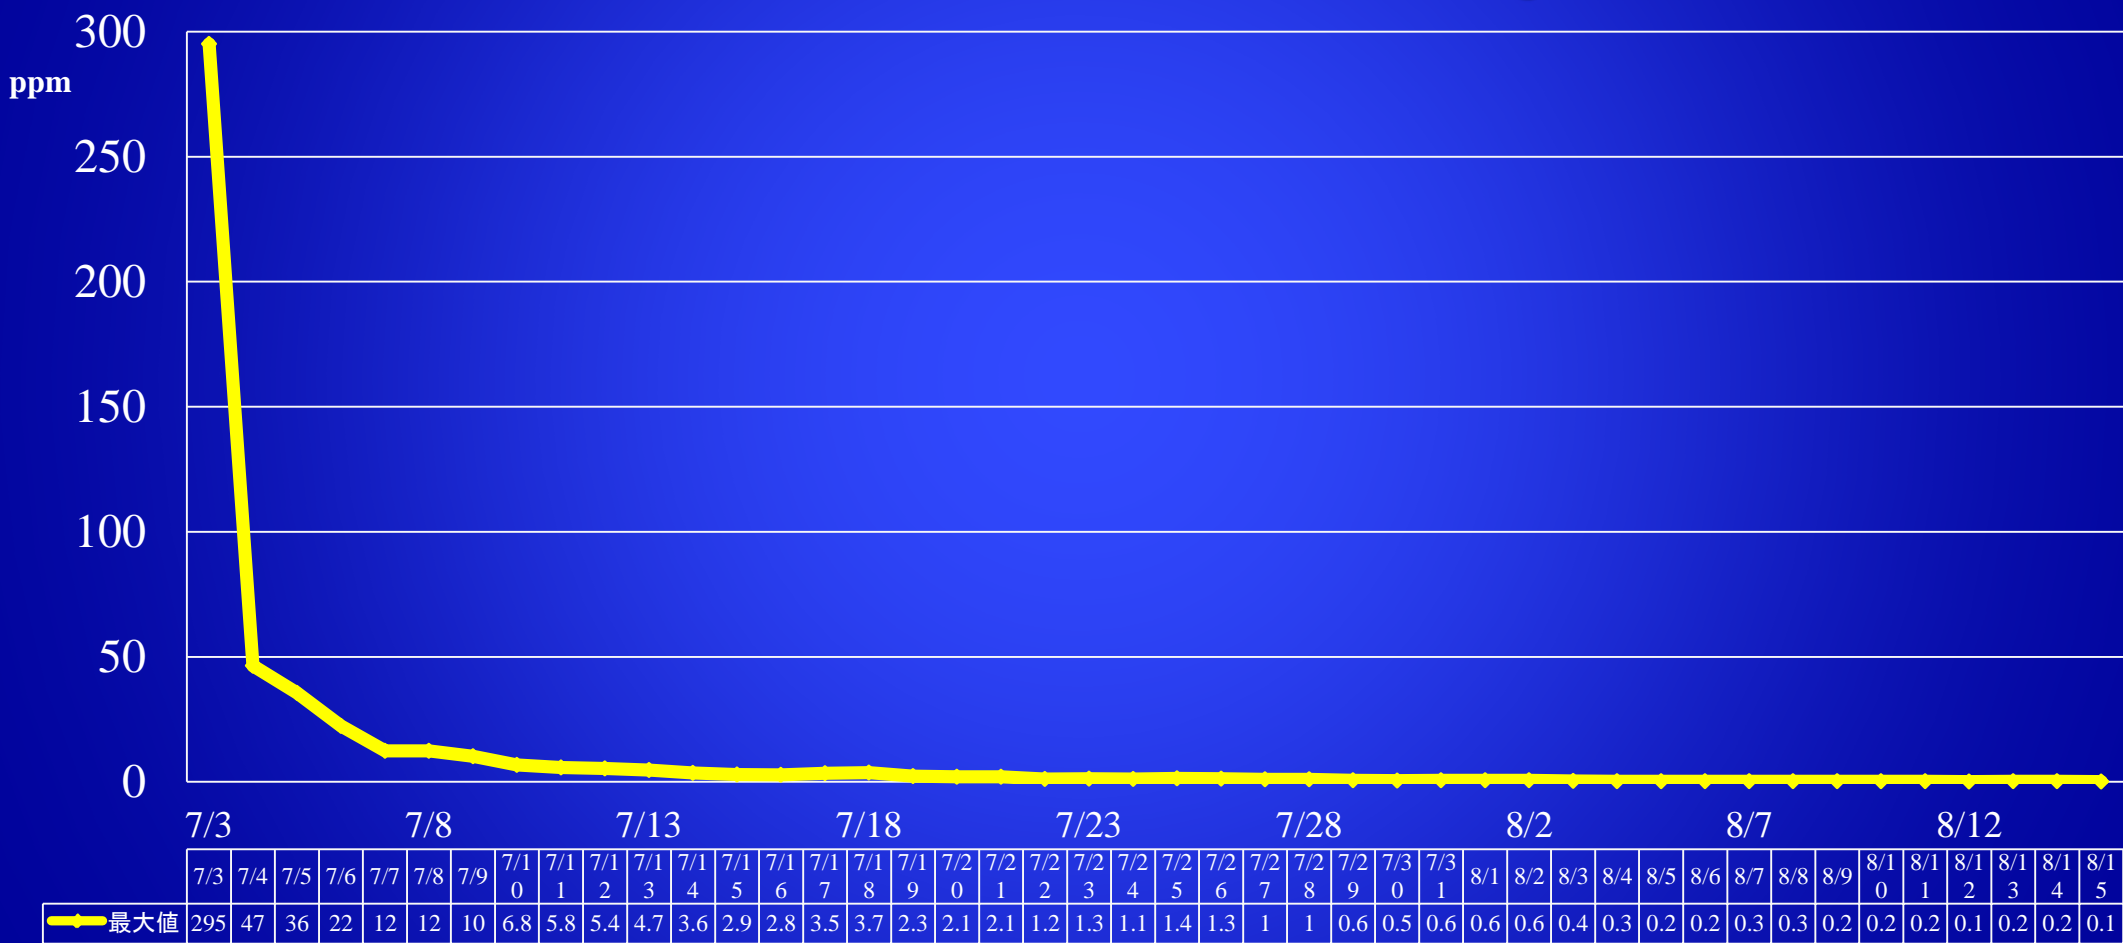
Residual Concentrations of Hydrogen Peroxide Vapour on the Stapler (PEI) after the Sterilization by STERRAD® NX

From 3Jul to 15Aug,2012

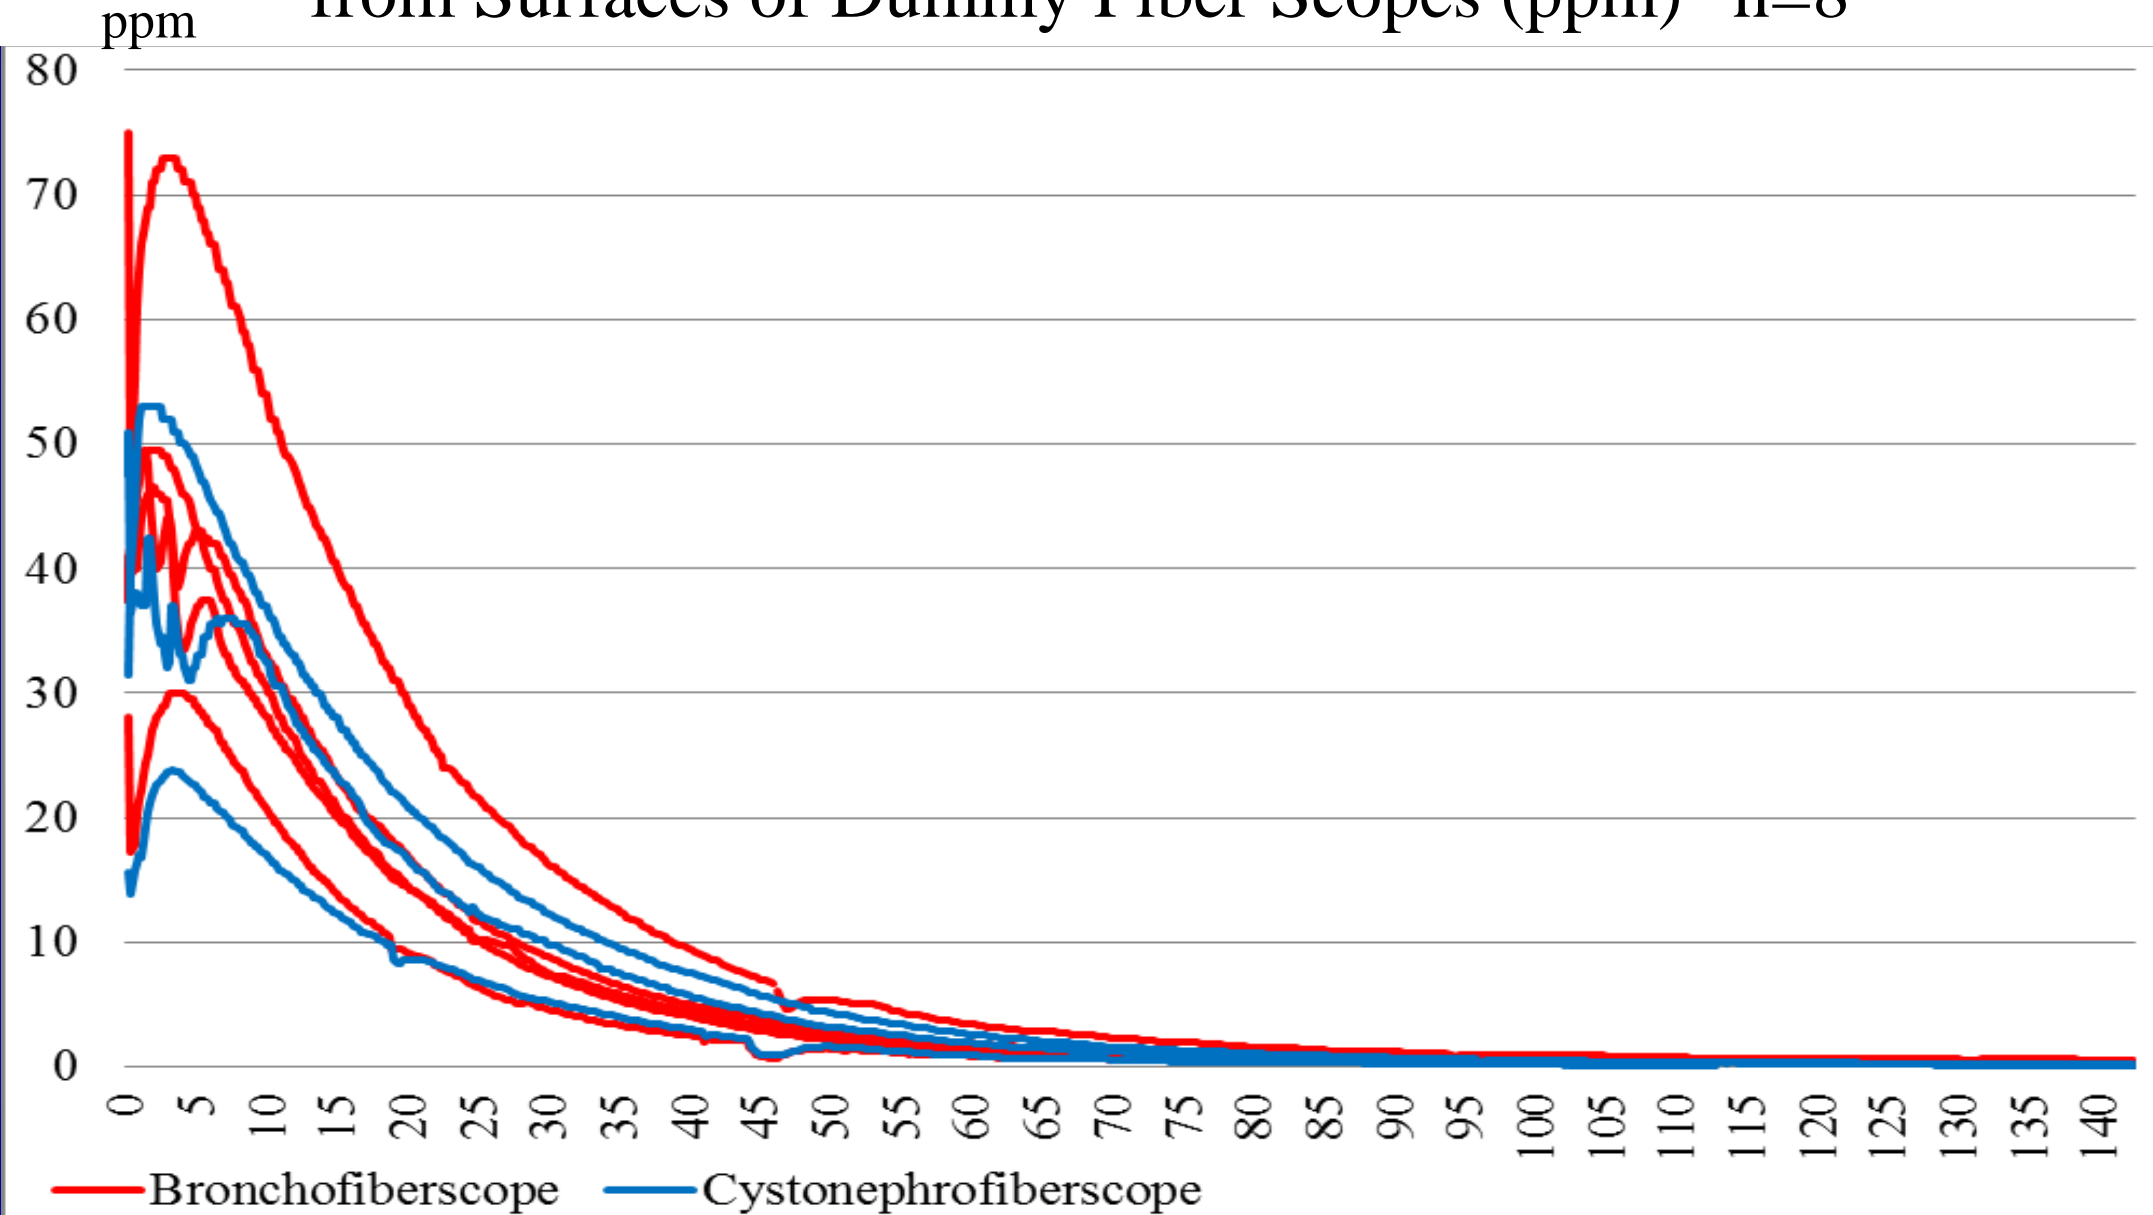
Hydrogen Peroxide Vapour from Surfaces of Dummy Fiber Scopes (ppm) n=8

- The residual concentration on the dummy flexible fiberscopes showed also more than 10ppm for 18 to 40 hours after sterilisations.
- The adverse events affecting mucous membranes have not yet been proven, however, healthcare workers should carefully observe the occurrence of adverse events among patients in order to maintain safety.

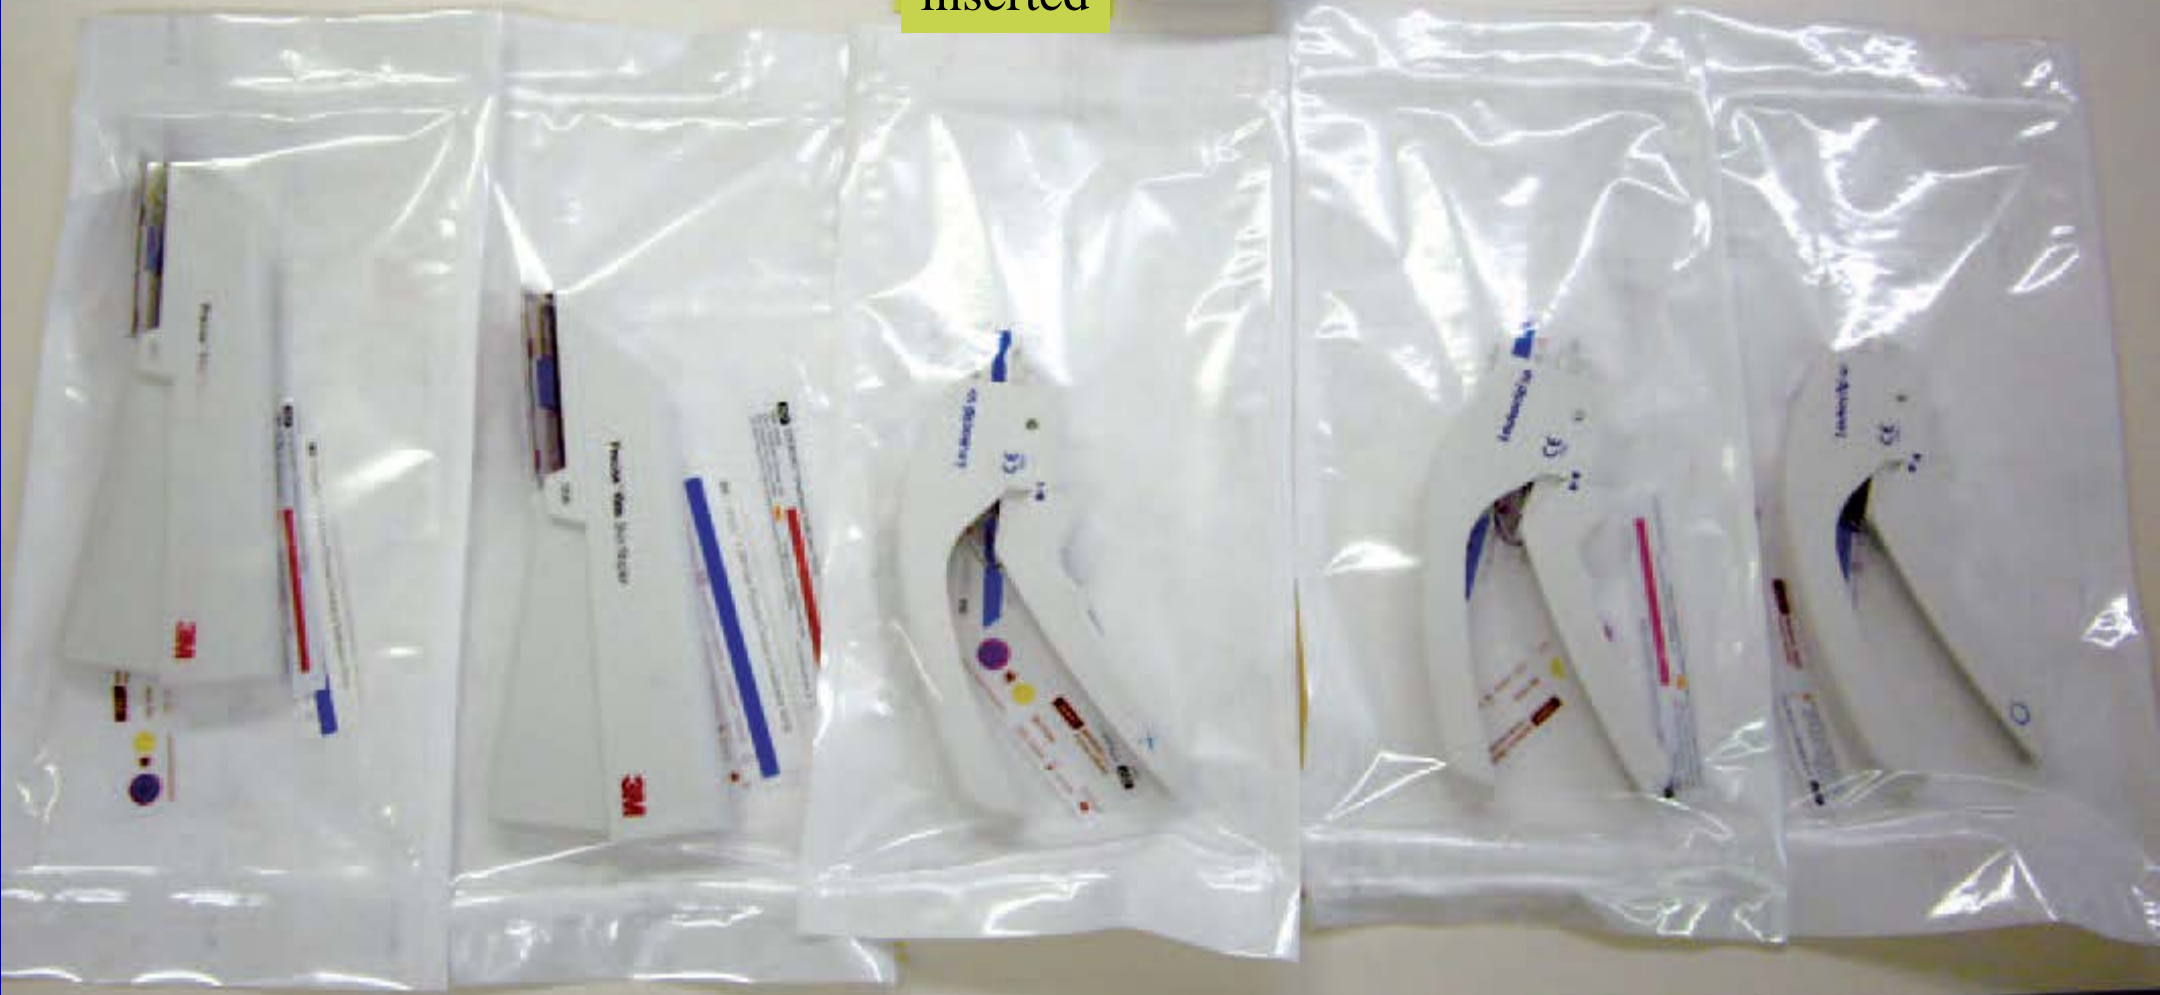
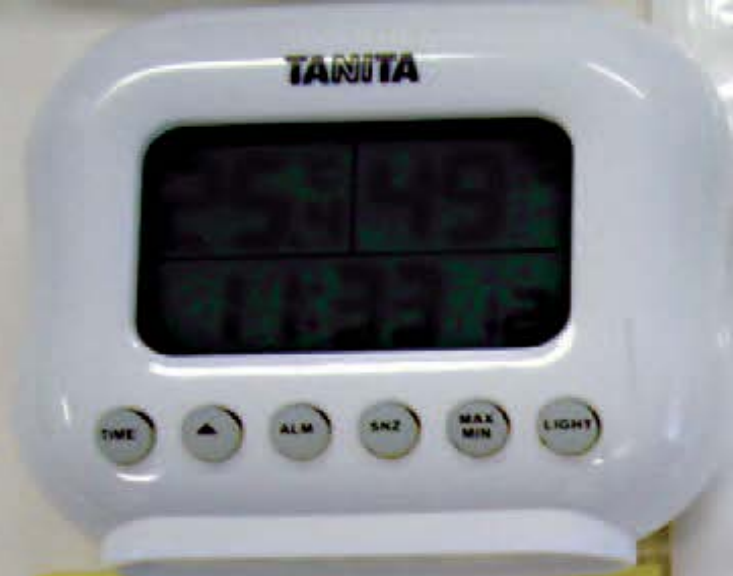
2011.8.21
10:37

inserted

- CI is not intended to guarantee the sterility of medical equipment after the sterilisation.
- Class 1 process indicator is used for HP sterilisation.
- It is recommended that CI should be inserted into and put on the surface of each sterilising pouch with device or instrument, and that the colour change of CI should be confirmed after sterilisation process.

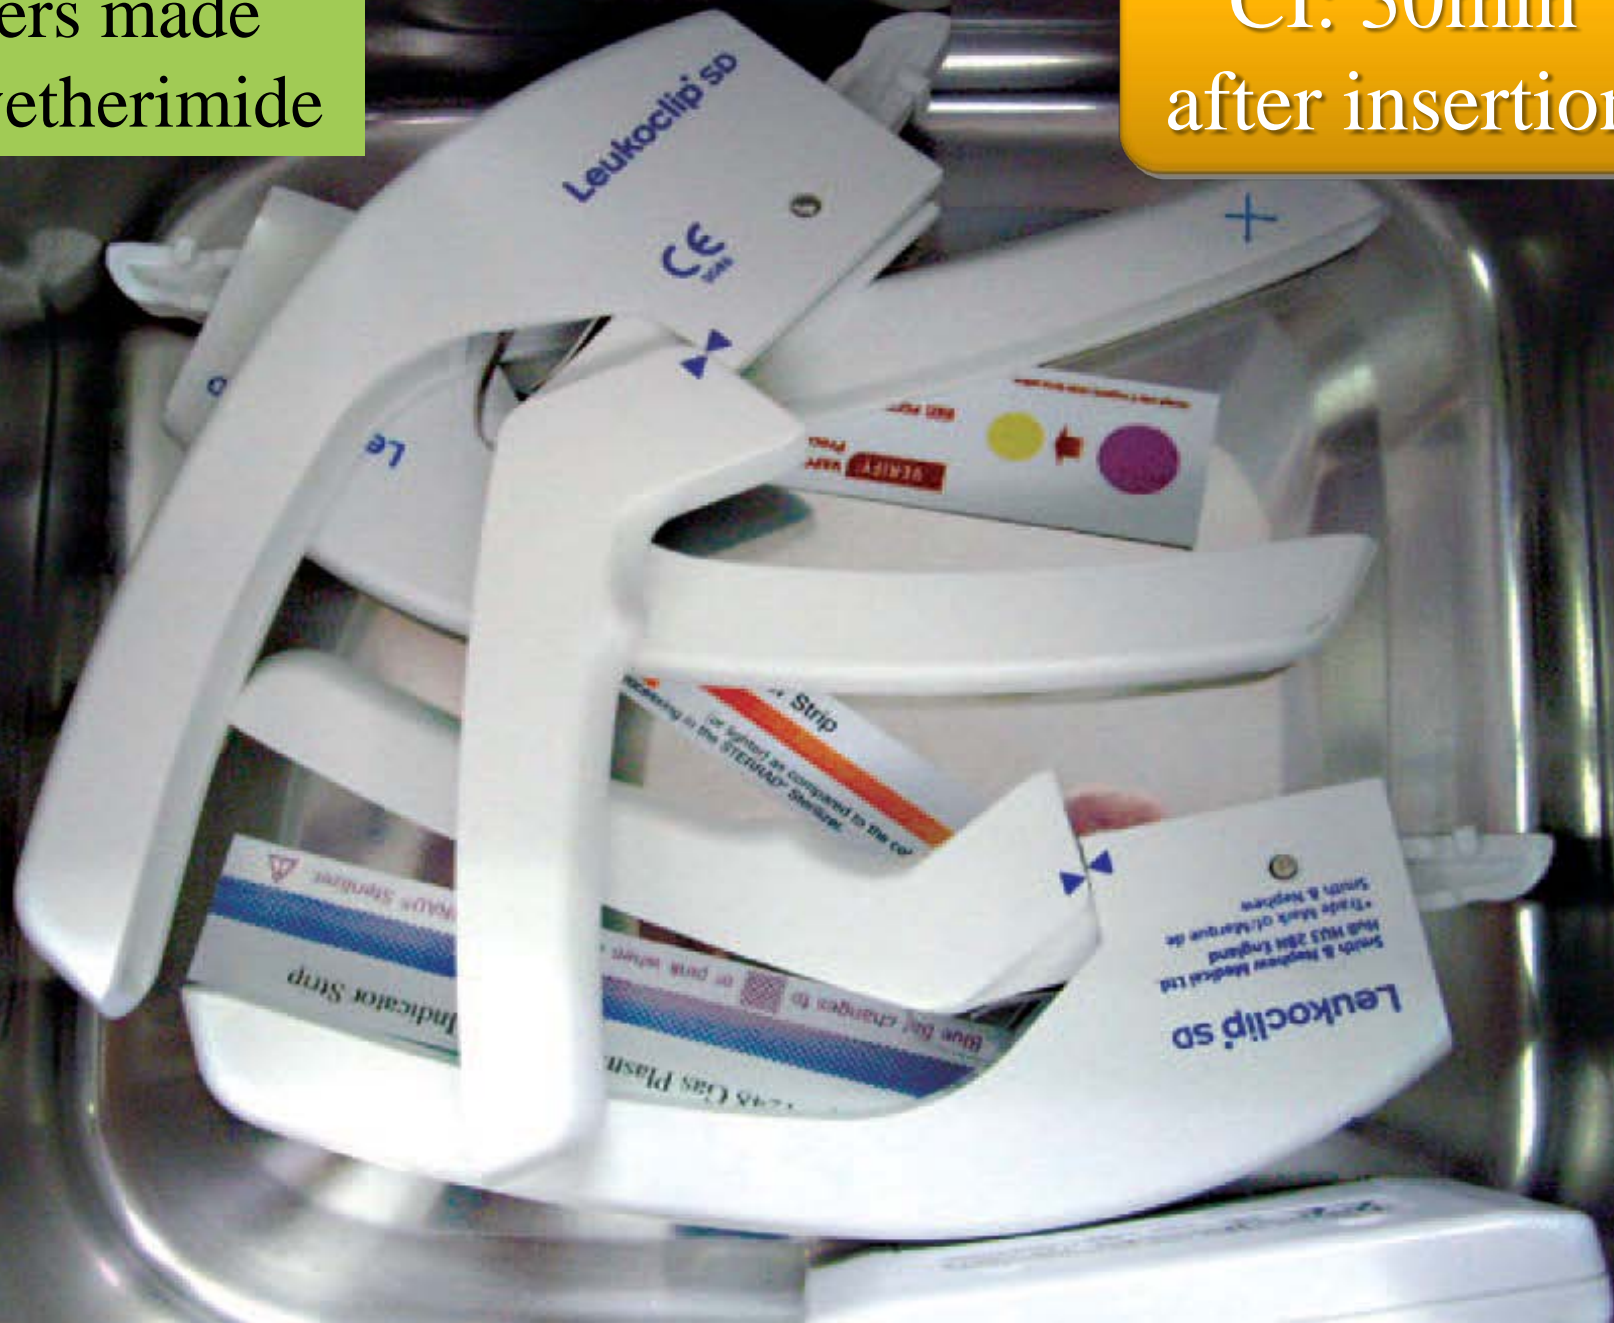
Staplers made
by polyetherimide

CI: 30min
after insertion

CI: 60min
after insertion

- Before sterilisation, the colours of all three kinds of CIs contacted with reusable plastic devices sterilised by HPV and sealed in the sterilising bags or in the stainless steel containers were changed completely or incompletely.
- The colour change of CI endpoint is confirmed macroscopically.
- The macroscopic confirmation is easy method, however that is depending on the personal sense
- In three kind of CIs tested this time, both colour before and changed one after sterilisation belong to similar colour groups which means to may result in the misjudge of colour change.
